# Reclaiming Structural Wood at Scale

From Airship Hangar  
to Portfolio Reuse

June 2026

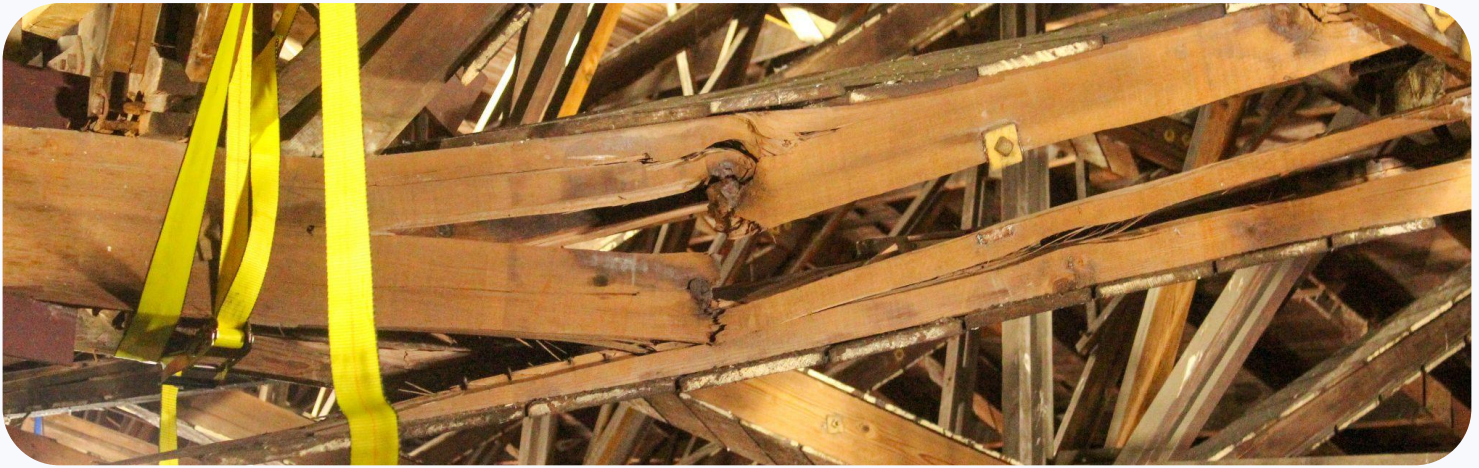
Damaged wooden beams within a complex truss structure, secured with yellow straps.

Originally, the plan was to repair Hangar 3 to address its hazardous structural conditions and restore it for future use. Yet efforts to rehabilitate the damaged trusses proved ineffective, and structural engineers could not identify a feasible pathway to safely repair Hangar 3's progressing structural damage. A temporary internal shoring system was installed and monitored for defects on a yearly basis while long-term options were evaluated.

Hangar 3's long-span timber arches operated in a seismically active region for more than 80 years. Damage records note a progressive dip in the roof structure, attributed to earthquake-related buckling and cumulative core distress. Digital scanning of the structure conducted during preservation evaluation confirmed sagging and settlement in several truss assemblies, prompting temporary shoring to stabilize the roof assembly.

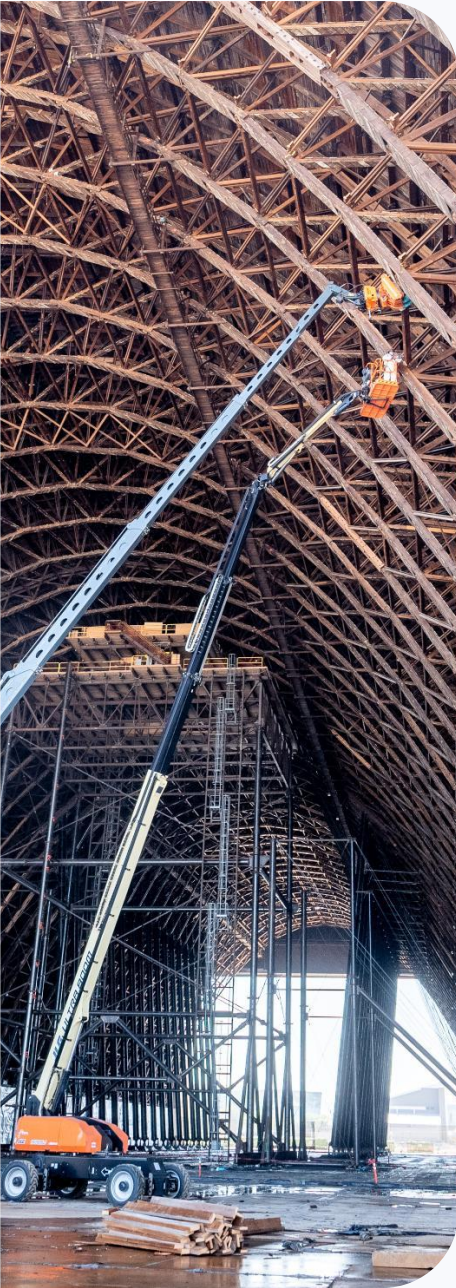
Temporary steel pillars supporting the Hangar 3 structure.

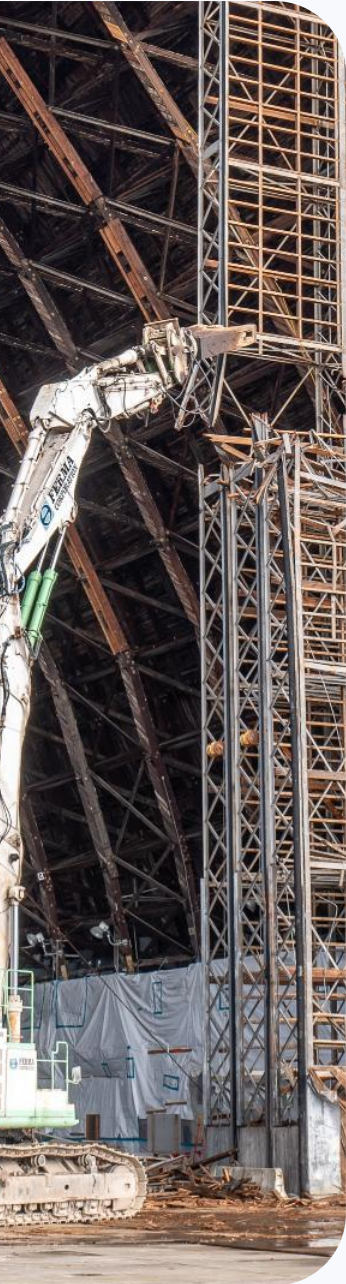
Multiple pieces of heavy machinery, including a high-reach excavator, collaborate to tear down the massive wooden sections of the hangar.

The Hangar 3 team approached deconstruction innovatively to minimize exposure to contaminants and maximize efficiency. Crews first reviewed lumber members' conditions to evaluate if they were fully intact and worthy of salvage in each individual truss bay. Salvage was a practice of precision: selected pieces were stabilized with a long-reach excavator, cut free, and lowered in a controlled manner.

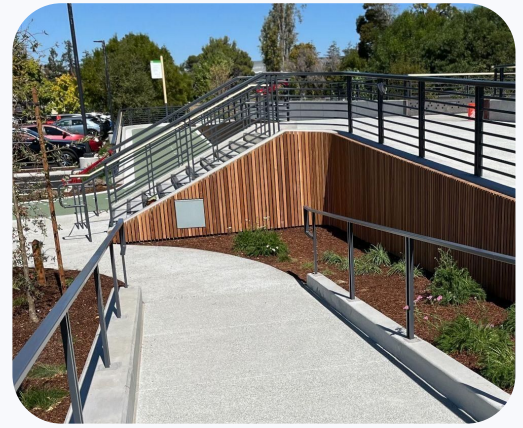
Moffett Park Green Link Bridge showcases the wood in a decorative facade.

The first installation of Hangar 3's salvaged boards can be found at the **Moffett Park Green Link Bridge** in Sunnyvale, California. This project uses 4,750 board feet as a decorative façade on a ramp retaining wall, creating a publicly accessible landmark. This pedestrian and bicycle bridge over Valley Water's West Channel connects Green Link Pathways on either side, providing a key connection that improves car-free transportation options in the neighborhood.

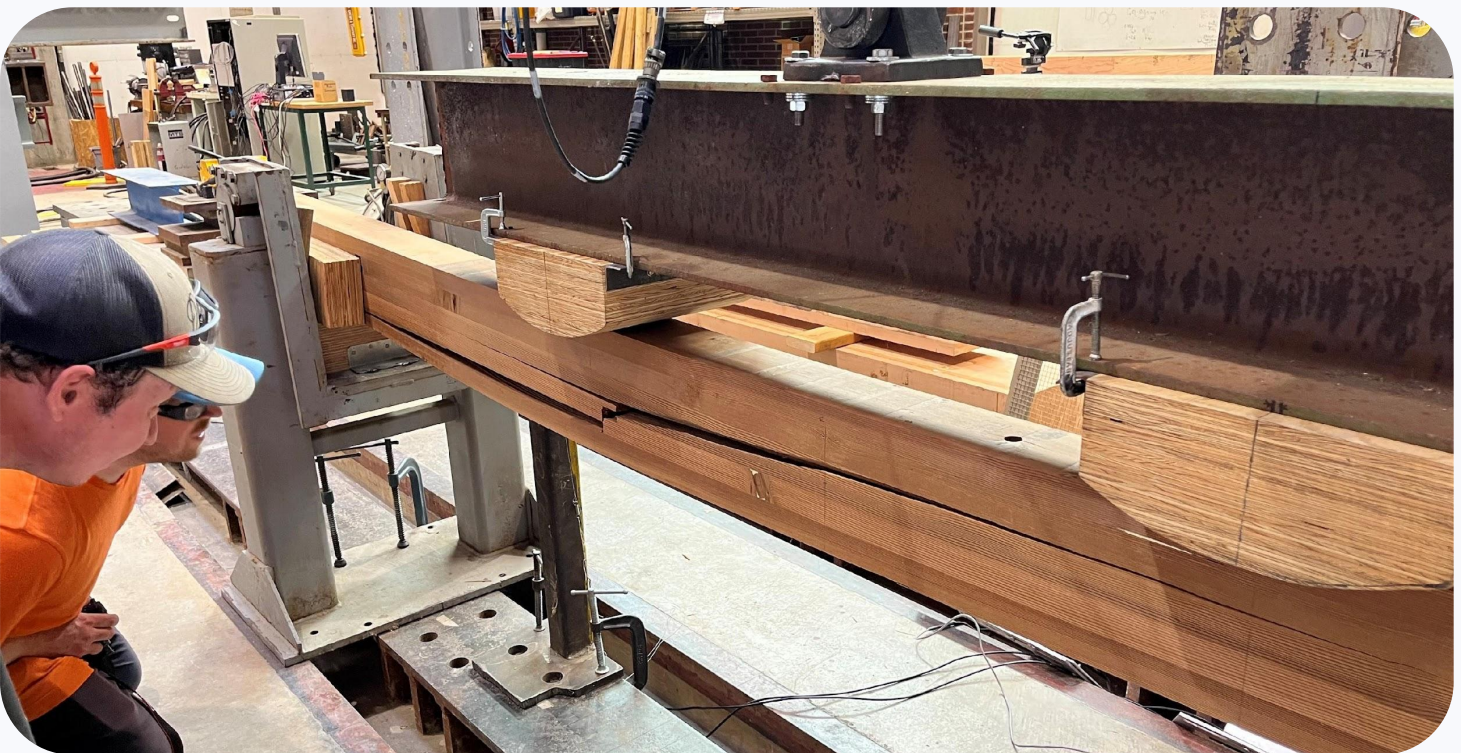
Wood strength and stiffness testing at Oregon State University's Wood Science and Engineering Lab.

Small-batch samples were sent to Oregon State University Wood Science and Engineering Lab for preliminary mechanical testing to characterize the static bending properties of the reclaimed Douglas-fir—specifically its modulus of rupture and modulus of elasticity.

Following bending strength tests, samples were extracted to determine moisture content and density, two variables that help explain how lumber behaves under stress. 30 boards were also scanned using imaging equipment designed to detect internal characteristics; however, the wood's darkened surface reduced predictive accuracy relative to typical new lumber.

Despite its age, results indicated consistent structural behavior within viable performance ranges. A limited number of glulam specimens manufactured from selected boards demonstrated comparable bending strength and stiffness to new lumber. Collectively, the testing established a measurable performance baseline for the reclaimed Douglas-fir, informing subsequent grading, manufacturing correlation studies, and structural validation efforts.

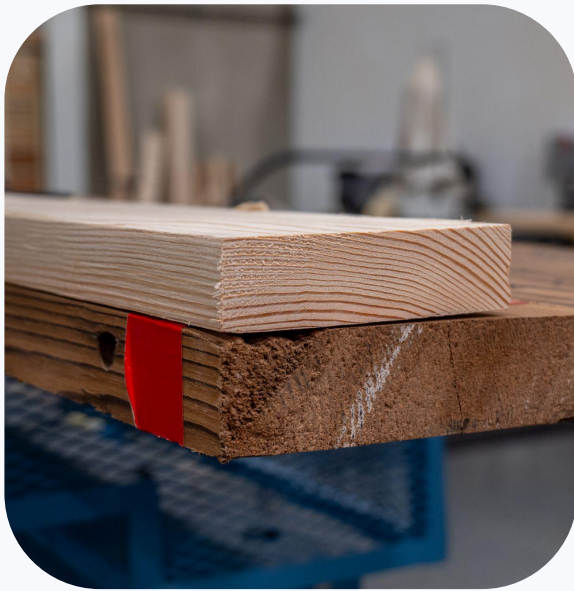
Squared and cleaned lumber next to the original salvaged condition of the wood.

The Hangar 3 material arrived as historic true-cut lumber – often more than two inches thick – cut at angles and rarely squared. Before structural evaluation could begin, ends had to be squared, surfaces cleaned, and dimensions rationalized. Moisture content added another layer of complexity. The lumber was drier than typical production stock. Standard in-line scanners struggled with the wood’s darkened patina, so technicians reverted to first principles: weigh, oven dry, and weigh again.

The same darkened surface that gave the lumber its rich character also interfered with optical grading systems. Light refracted differently and knots were harder to detect. Machinery vendors had to reprogram the software and recalibrate scanning parameters, and programmers adjusted algorithms one grading parameter at a time. The process deviated substantially from standard production workflows.

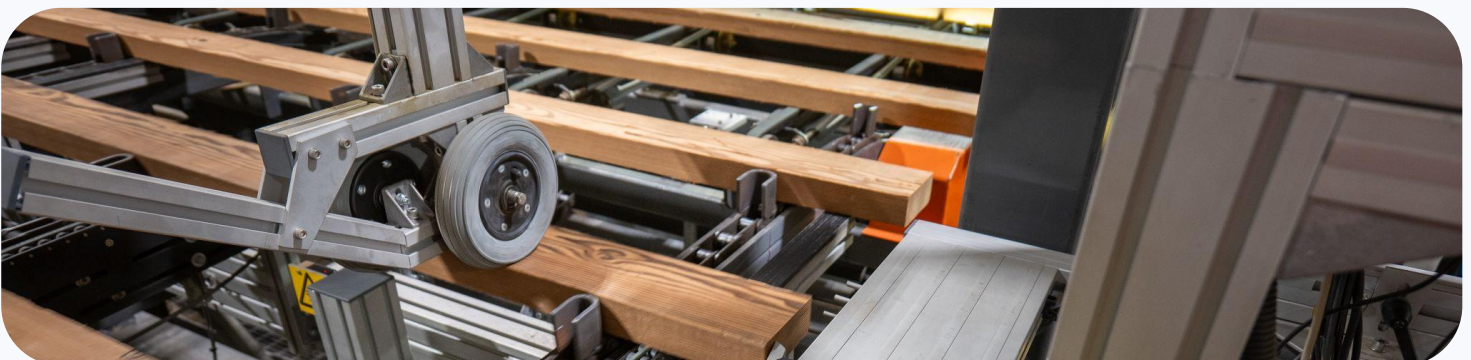
Machine verification of lumber regrading.

The regrading process blended human judgment with machine verification. Certified lumber graders visually evaluated slope of grain, checks, and knot size, while machine stress rating systems measured stiffness and strength. Destructive testing revealed wide tensile strength variation: some pieces exhibited strong tensile behavior, while others were brittle. Approximately 30 L1 and 30 302-24 glulam tension lamination samples, representing common glulam lamination grades, were destructively tested to map this variability. With no standardized grading pathway for reclaimed lumber, the team built redundancy into the evaluation process.

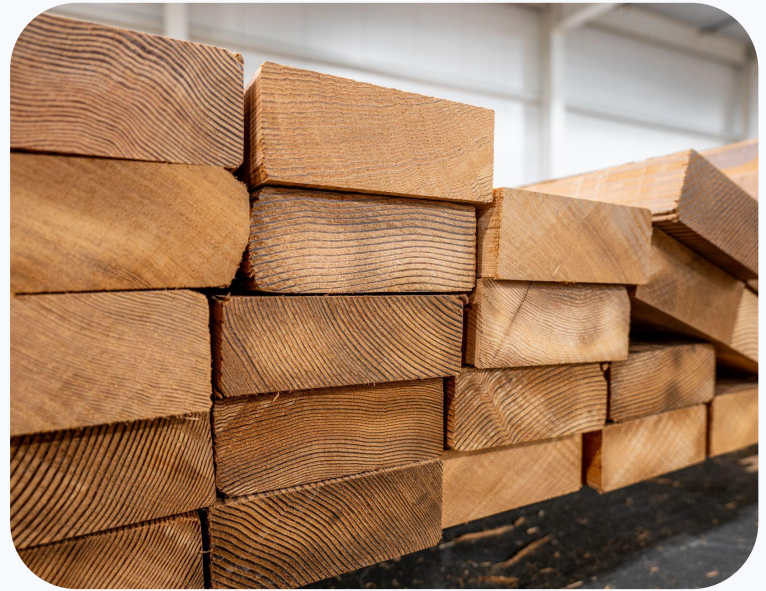
End grain of the salvaged wood.

The results directly informed manufacturing. Planning required multiple passes because the material exceeded modern dimensional norms, and the wood's density further challenged equipment. Adhesive application systems required modifications, since most adhesives used in mass timber manufacturing depend on moisture to cure. Options considered included raising ambient humidity, misting on adhesive lines, and longer press times. These steps were tested and verified by quality control practices during production.

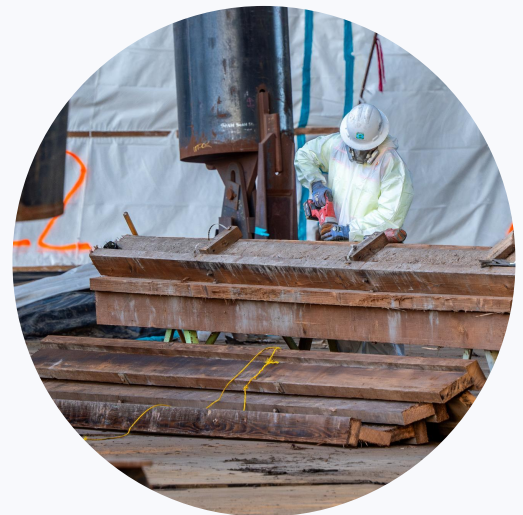
**Middle:** A worker wearing a protective suit, uses a hand tool to remove unsalvageable pieces from boards.
